Tighe and Bond, Inc. has been retained by the Town of East Hampton to conduct a Phase I Environmental Site Assessment (ESA) of the property located at 13 Watrous Street in East Hampton (the site). The purpose of this Phase I ESA is to evaluate the potential for contamination of soil, groundwater, and surface water resulting from current or historic site operations, use, and conditions at the site. This information will be used to determine if there is potential for current or historic releases of hazardous substances or petroleum products to the environment. This report is prepared for the exclusive use of the Town of East Hampton. This Phase I ESA was performed in general accordance with the requirements defined in the Connecticut Department of Environmental Protection (CTDEP) Transfer Act Site Assessment Guidance Document, dated June 1989, and revised November 1991 and the guidance for Phase I Site Assessments set forth in the June 12, 2000 Draft Site Characterization Guidance. This report also generally follows the standards of the American Society for Testing and Materials (ASTM) Standard Practice for Environmental Site Assessments (ASTM E1527-00 and E1528-00).

The site is loc

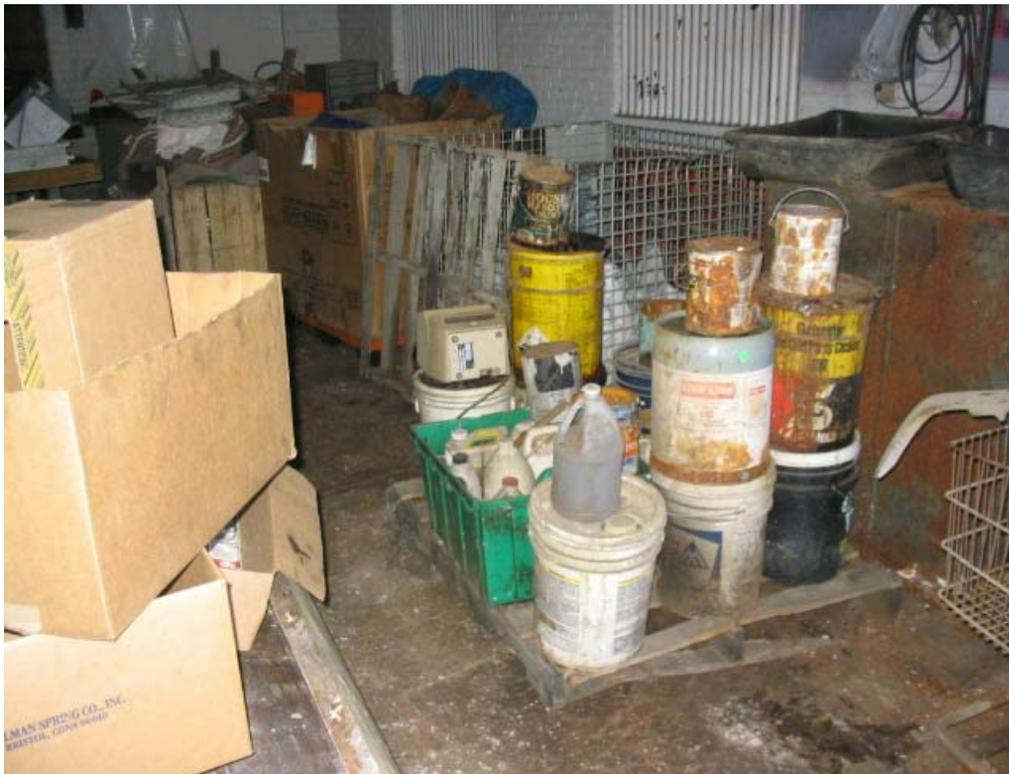
PHOTO: 01
LOCATION: Northern Section
DESCRIPTION: Assorted paint and solvent storage area.

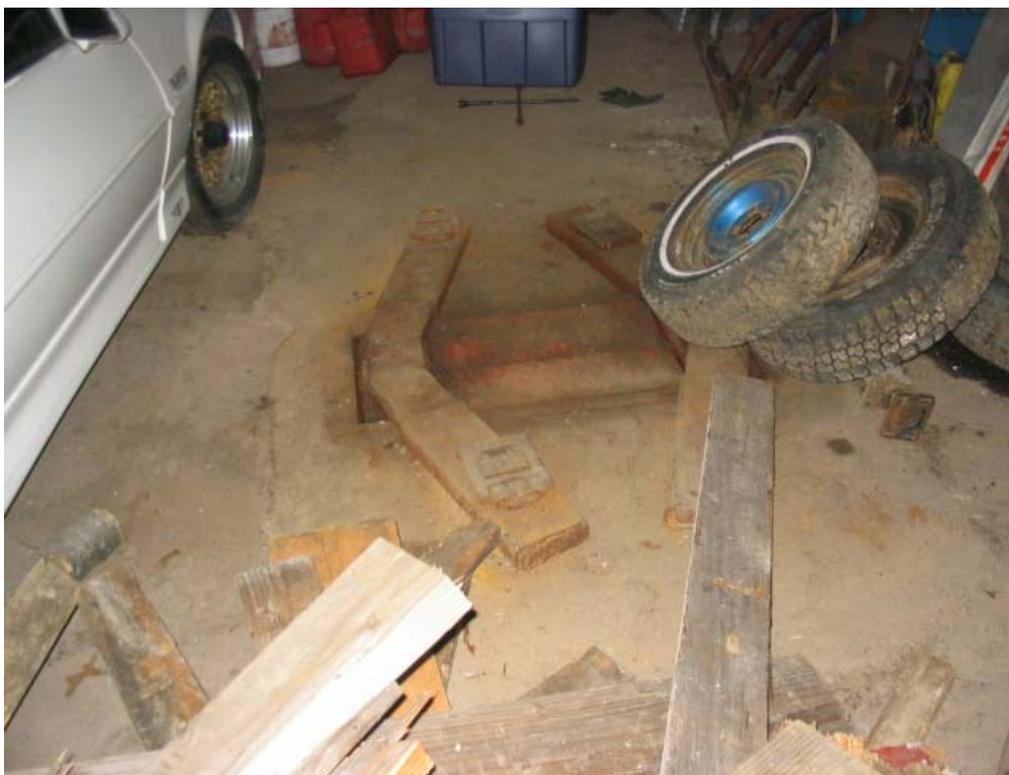
Hydraulic Lifts: An in-ground hydraulic lift system is located in the northern section of the building as shown on Figure 2. The hydraulic reservoir is below grade. The hydraulic lift was originally installed by Ghezzi Motors. At the time of the site visit, the hydraulic lift was not in use. The hydraulic fluid has not been removed or drained (site reconnaissance).

PHOTO: 02
LOCATION: Northern Section
DESCRIPTION: In-ground hydraulic lift

- **In-Ground Hydraulic Lift:** An in-ground hydraulic lift is located in the northern section of the site. The current tenant does not use the lift. However, the hydraulic fluids are still contained in the lift and present a potential environmental hazard. Potential COCs may include PAHs, and/or petroleum hydrocarbons.

Tighe & Bond, Inc. recommends that a Phase II ESA Scope of Work be developed and implemented to determine if a release has occurred from the PAOCs at the site. This investigation should, at a minimum, include the collection of soil and groundwater samples, particularly near stained areas inside and outside the site.

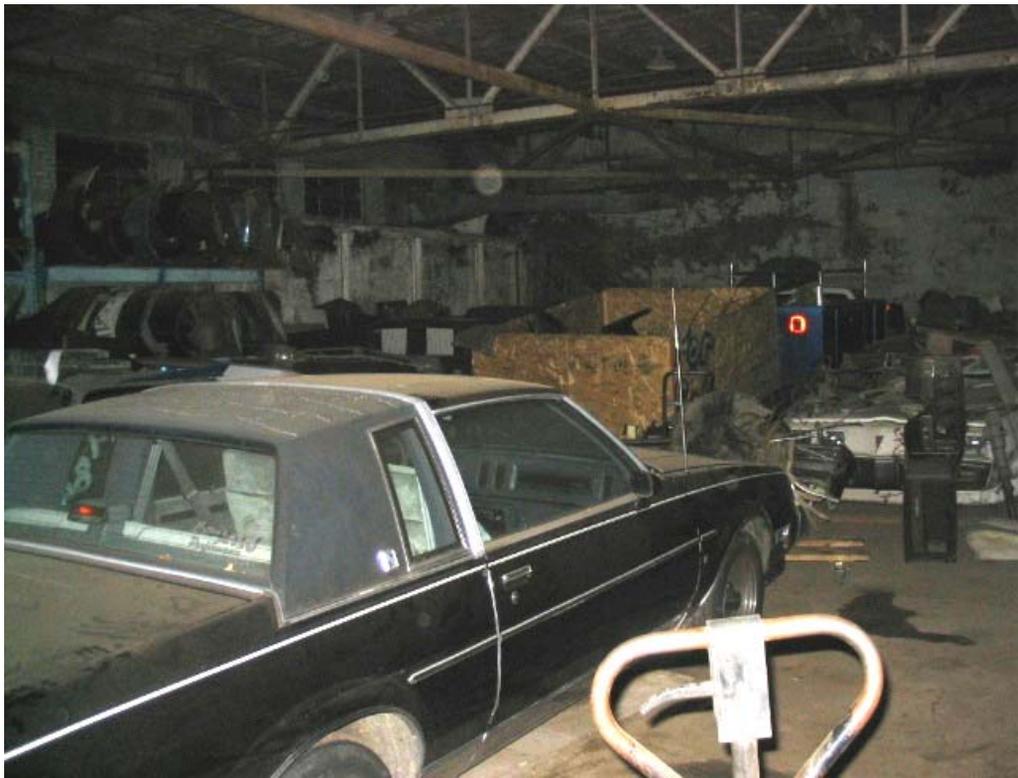
PHOTO: 03
LOCATION: Northern section
DESCRIPTION: Vehicle storage

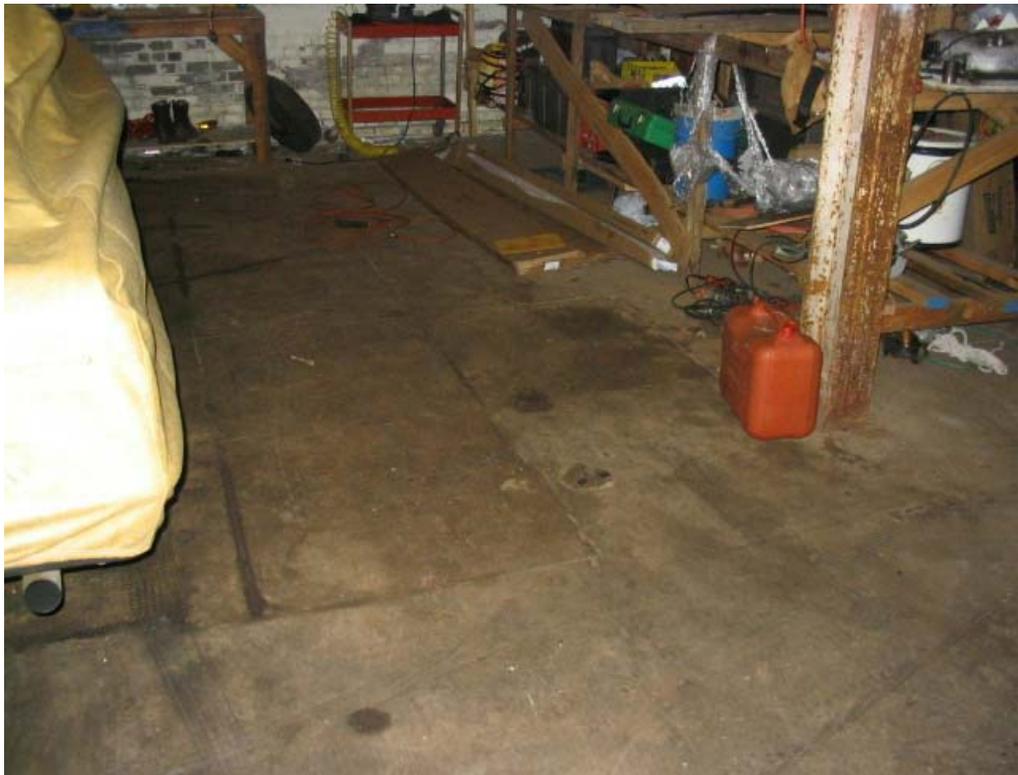
Stains were observed throughout the concrete floors. Robert Fuller pointed a floor drain located near the center of the room. The drain was covered by a wooden table and complete access to the drain was not possible. However, a pipe inside the floor drain appeared to head in a northern direction. Robert Fuller did not know the specifics of the drain system. Mr. Fuller also described the five-gallon buckets of lacquer thinner that were formerly in this building section. Approximately 30 buckets (total of 150 gallons) of lacquer were taken off site to be recycled. A metal panel in the concrete floor is located near the northern wall and it was lifted to expose the sub-floor. It is possible this area was once used as a machine pit.

PHOTO: 04
LOCATION: Central Section
DESCRIPTION: Exposed subfloor

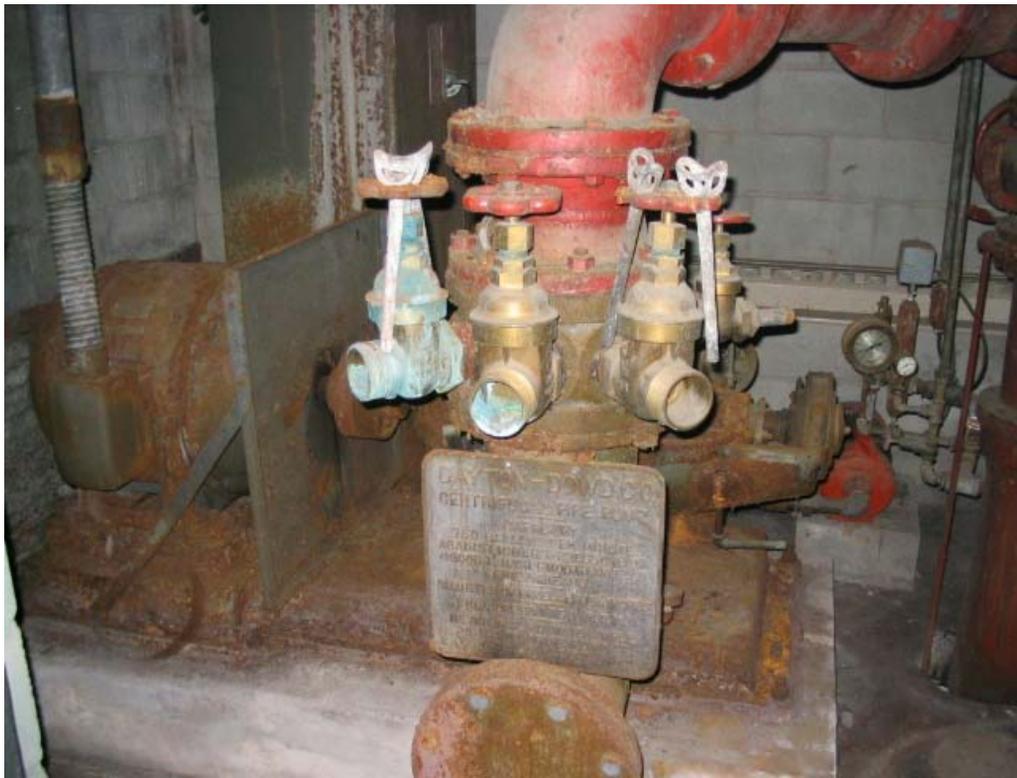
PHOTO: 05
LOCATION: Central Section
DESCRIPTION: Pump House

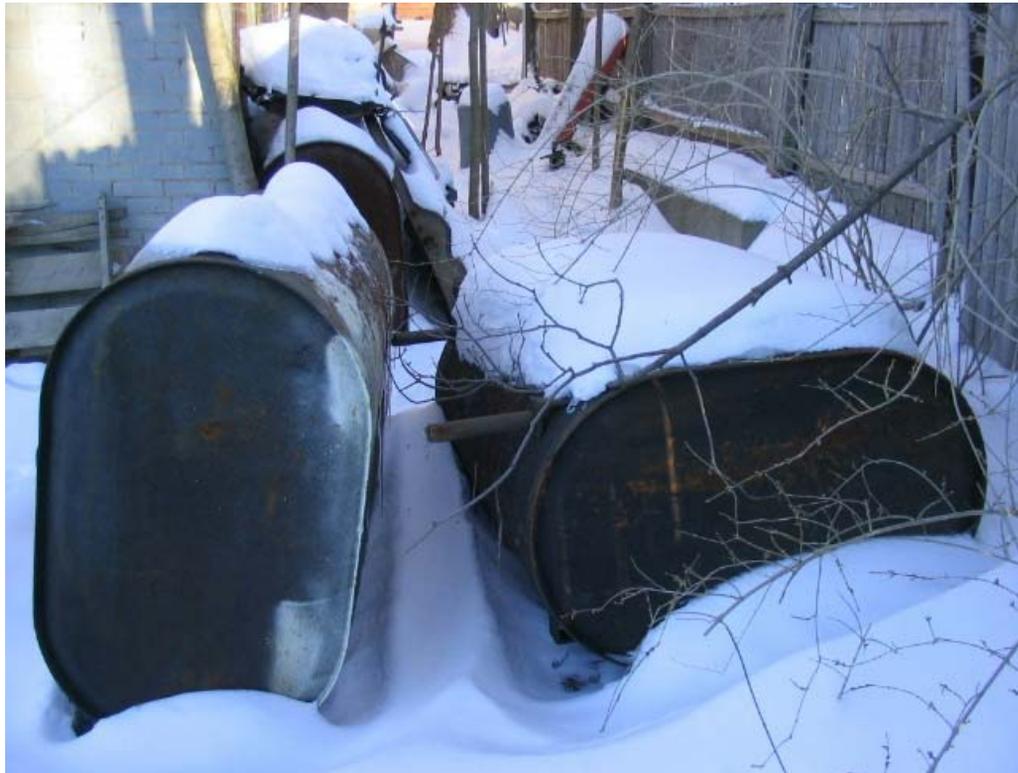
Aboveground Storage Tanks (ASTs): No ASTS are currently in use for heating purposes. The previous owner left behind three 300-gallon tanks filled with a motor oil-like liquid. The exact chemical composition of the substance was unknown to the current tenant. The current tenant recycled the oil in two of the tanks. A third 300-gallon tank remains on the property and contains a similar substance. The current tenant has made plans to recycle the remaining AST (Interview).

PHOTO: 06
LOCATION: Outside southern perimeter of property
DESCRIPTION: Empty 300-gallon above ground storage tanks

- **300-gallon AST Location:** Three 300-gallon tanks were contained in the northern section of the building. Minor floor staining was observed in the former AST storage location. The condition of the tanks is unknown but the potential exists that the one of the tanks has leaked and adversely affected soil or groundwater quality at the site. Potential COCs may include petroleum hydrocarbons and/or PAHs.

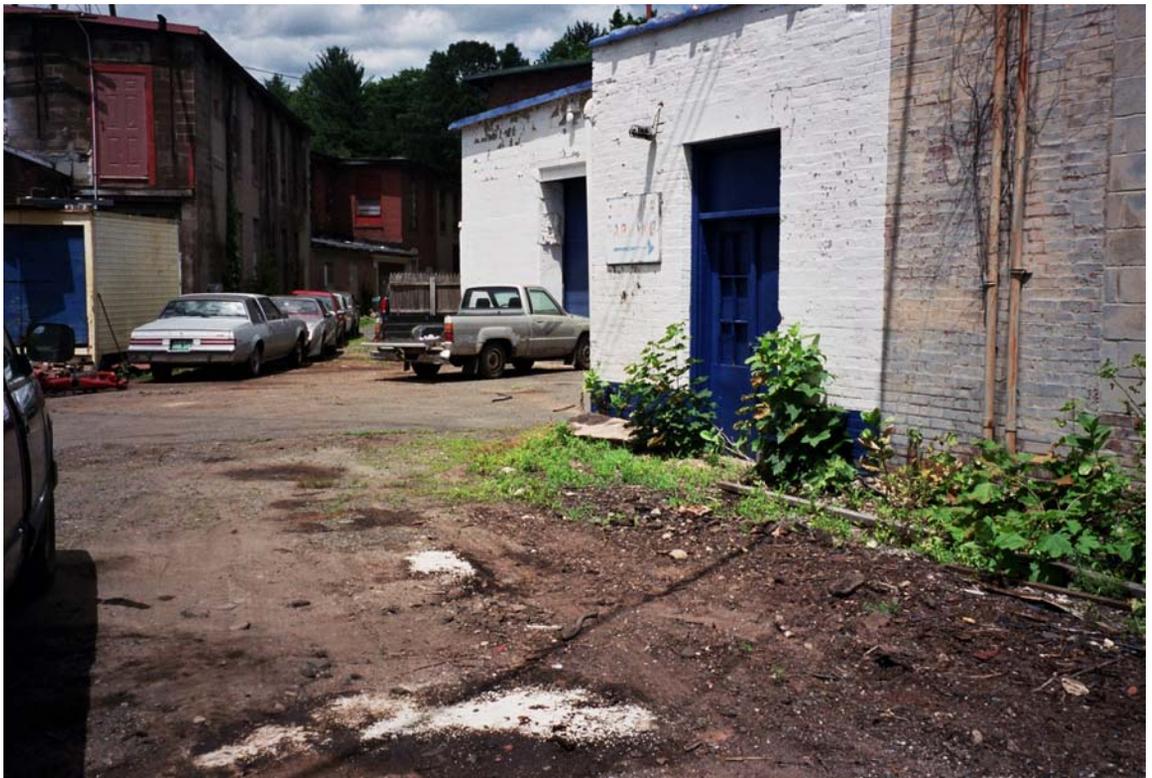
PHOTO: 07

Several areas of stressed vegetation have been observed on the property. Most of these areas coincide with vehicle storage areas. In particular, the western and southern

perimeters have stressed vegetation and areas of soil staining. No fill pipes or vents were observed on the site.

LOCATION: Western extent of exterior property

DESCRIPTION: Photograph taken February 2004. Photograph illustrates soil staining.

- **Exterior Areas of Stressed Vegetation and Soil Staining:** Current and historic site information suggests a potential for soil or groundwater contamination at the site perimeter. Automobile and refuse storage has historically occurred on the property exterior. In addition, a railroad track formerly traversed the western portion of the property. Stressed vegetation and soil staining has been documented during site reconnaissance. Potential COCs may include metals, VOCs, PAHs, and/or petroleum hydrocarbons.

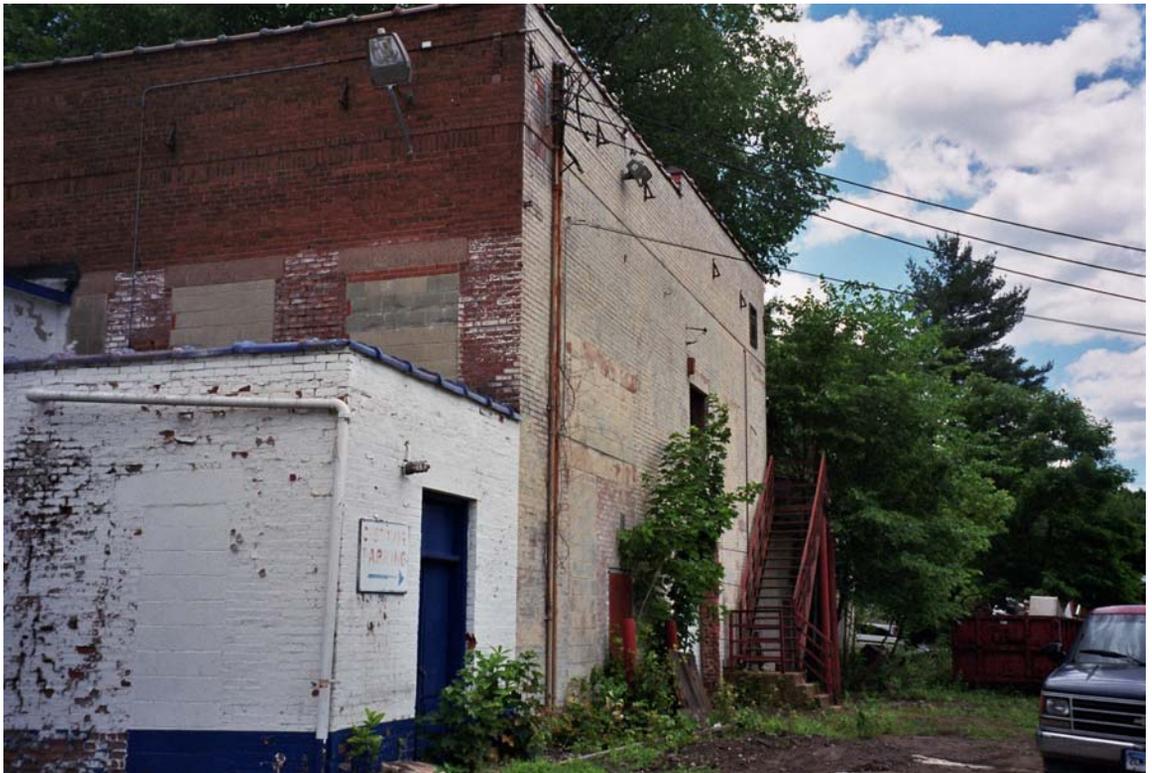
PHOTO: 08

LOCATION: Western extent of property.
